Westmeath Local Authorities

Building Access Report

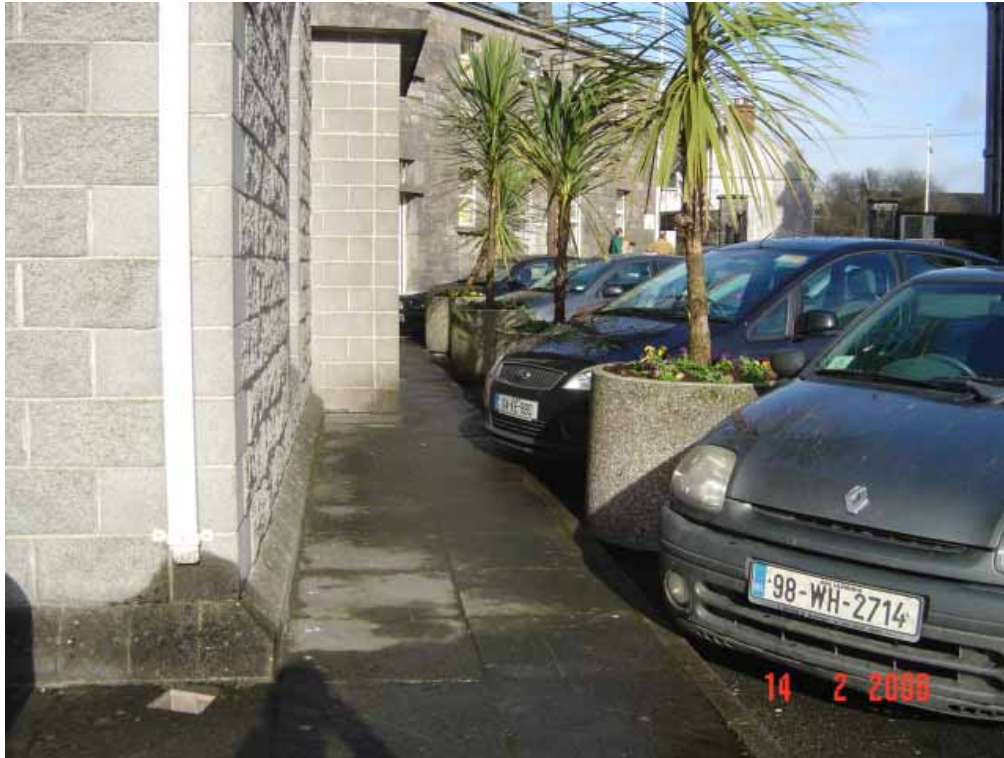
Fig. 4.1 The path to Governors house terminates here at the end of the housing building

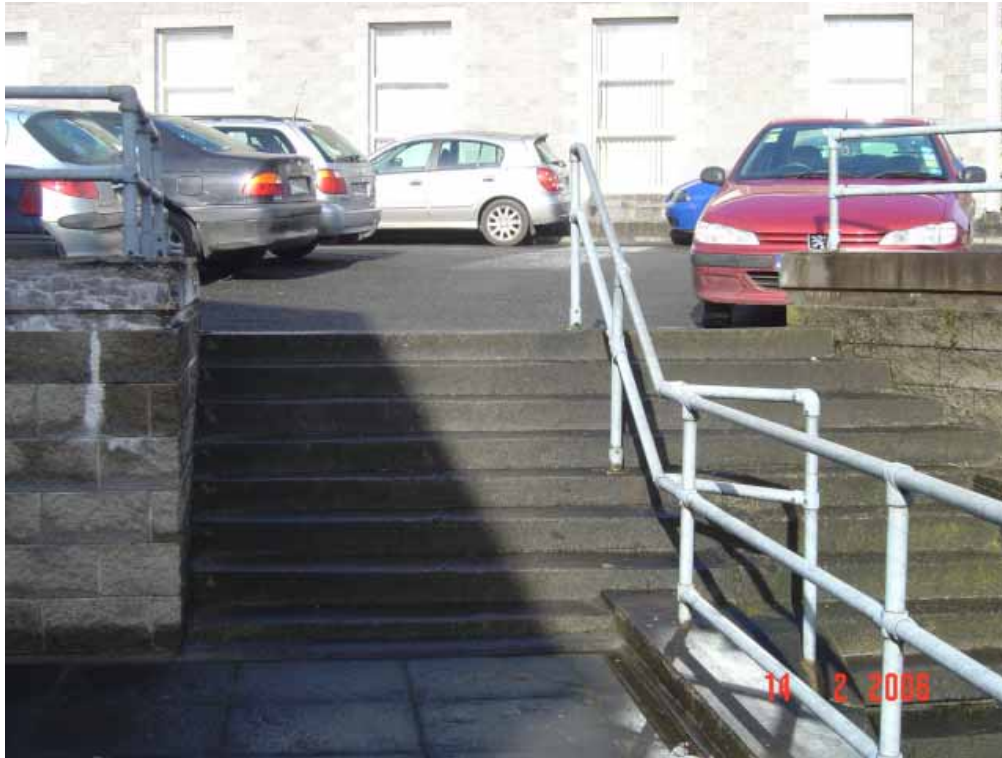
Fig 4.2 These steps make it impossible for anyone in a wheelchair to gain access to this office.

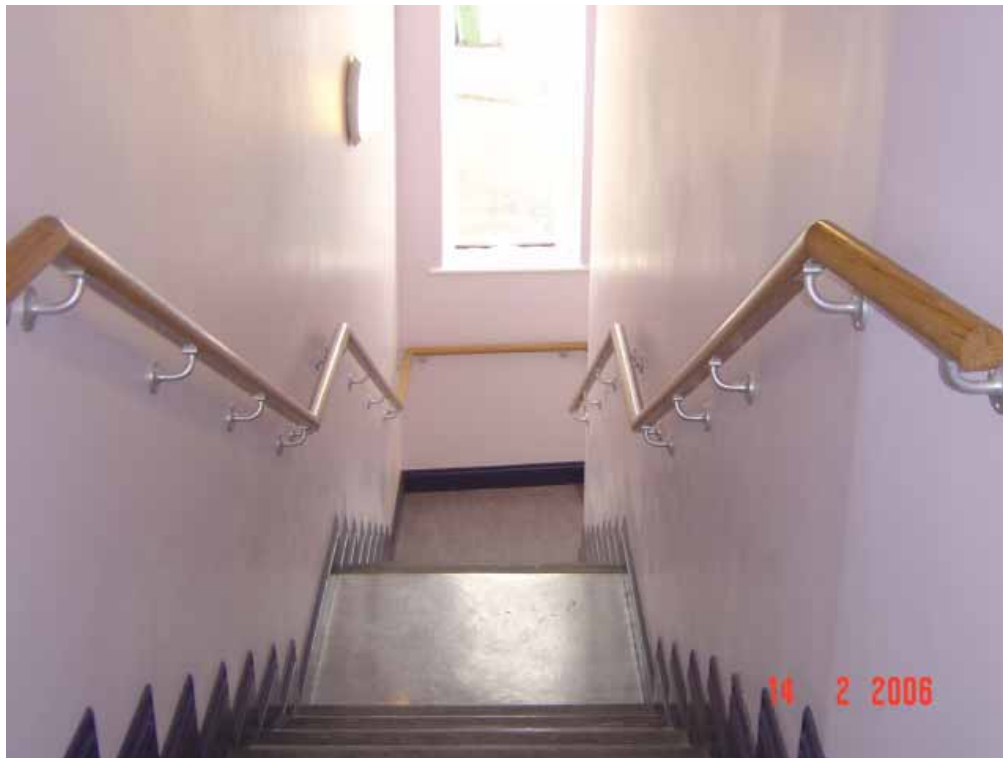
Fig 5.2 Stairs down from library showing good handrails but no tactile warnings.

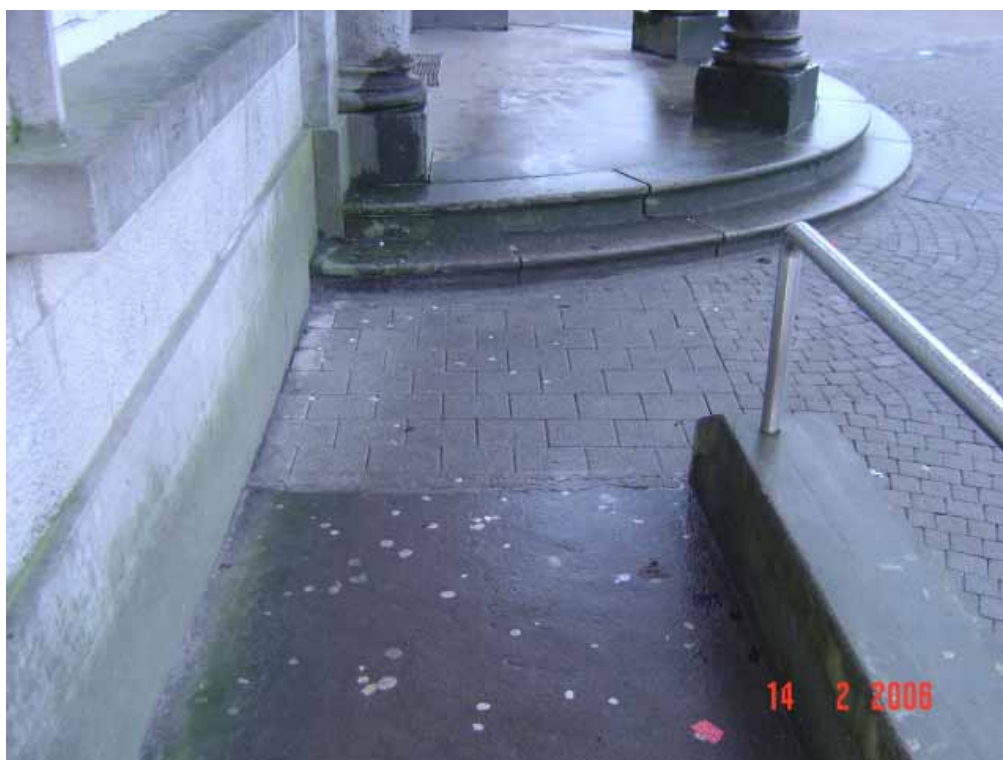
Fig 7.1 No Tactile hazard strips at bottom of ramp into the Arts Centre

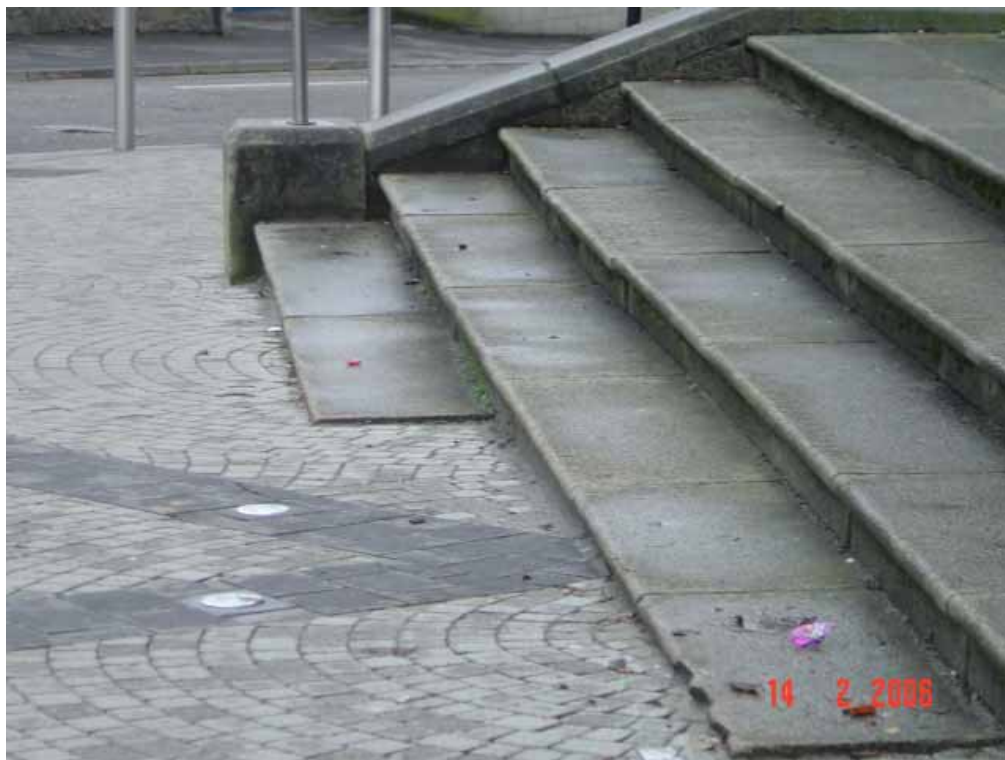
Fig 7.2 These steps have no tactile hazard strips plus the steps have no visual contrasting from the surrounding area.

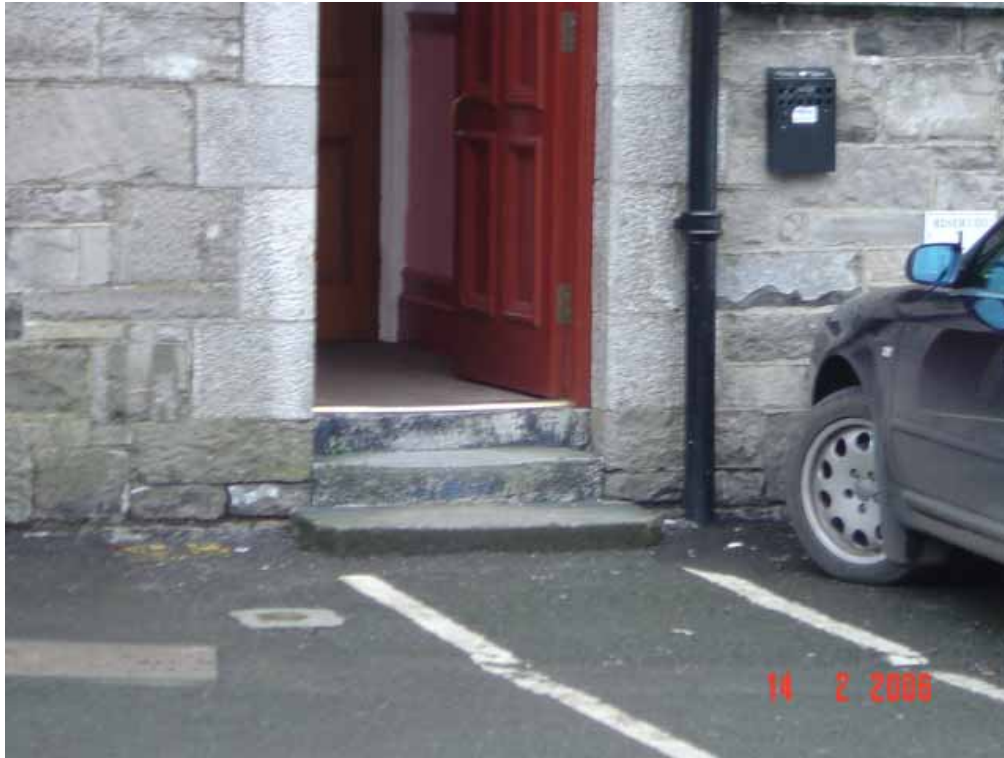
Fig 7.3 These steps have no tactile hazard strips nor are the risers consistent which is dangerous.

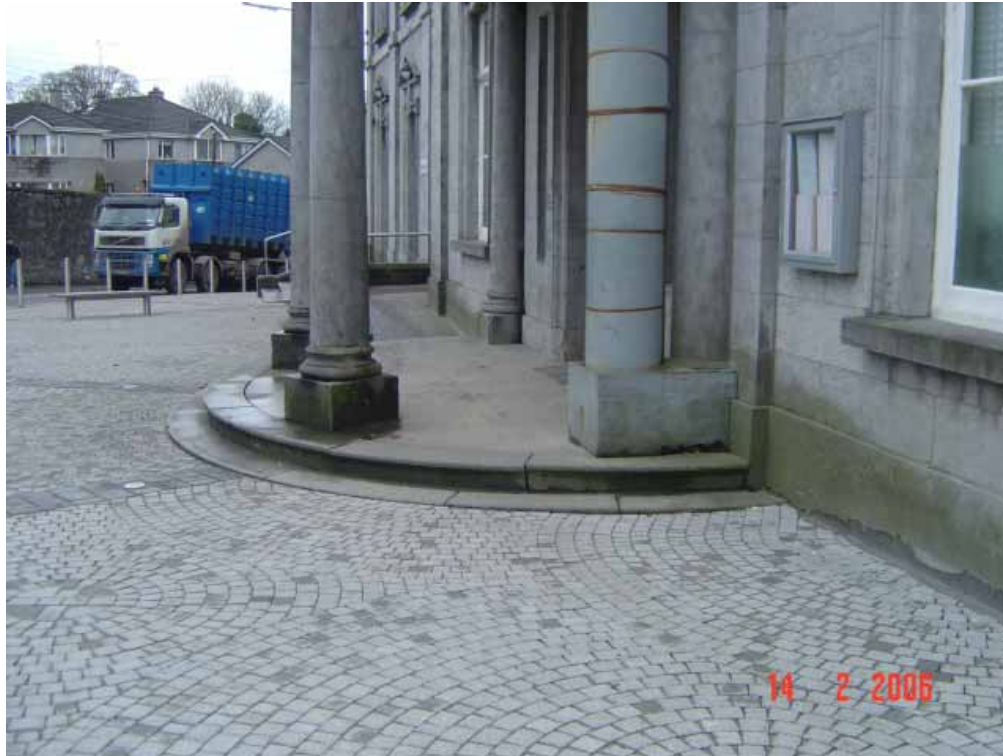
Fig 7.4 These steps have no tactile hazard strips plus the steps have no visual contrasting from the surrounding area

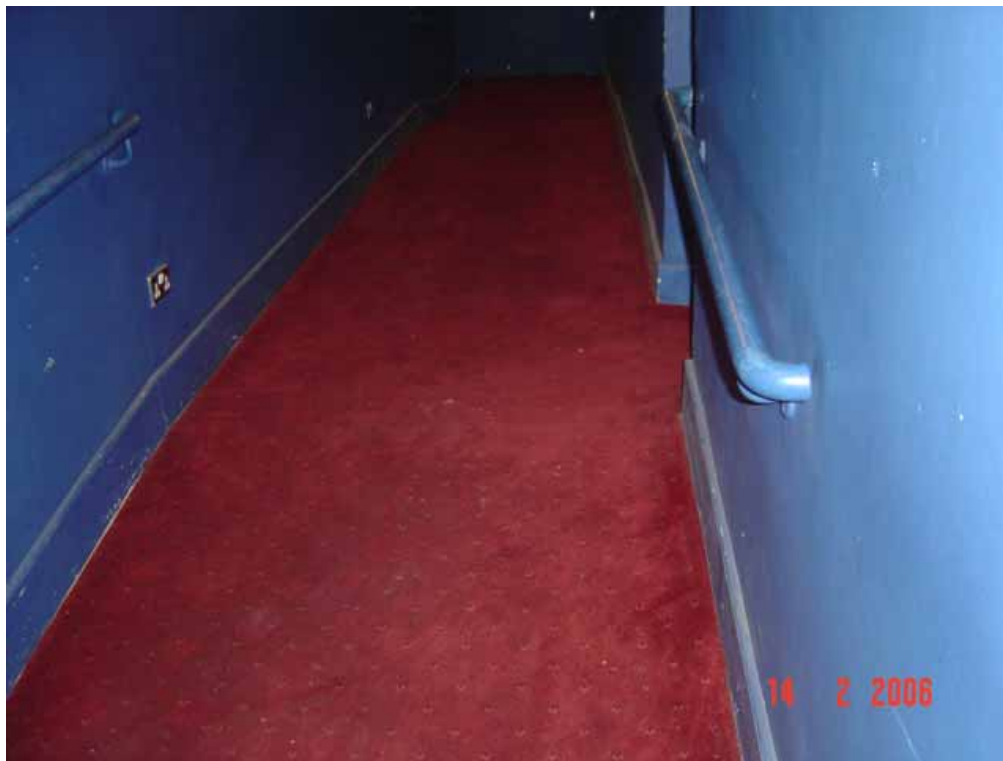
Fig 7.5 Ramp section with handrails but unfortunately to tactile hazard warnings at the top or bottom

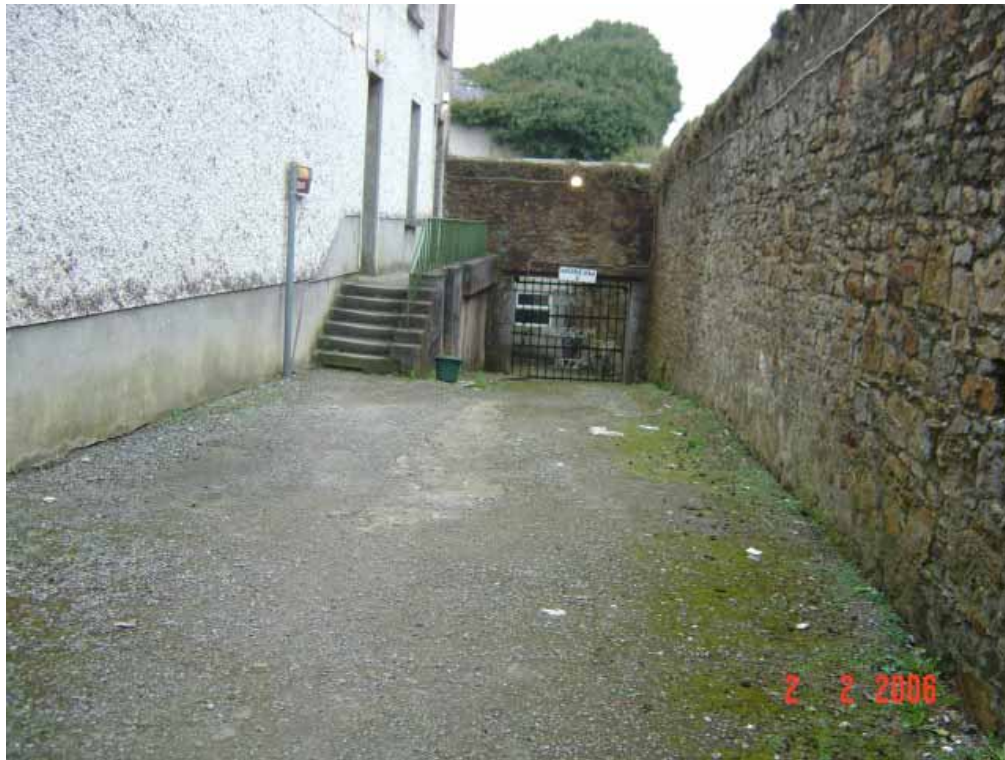
Fig 8.1 No designated path to the entrance and poor surface.

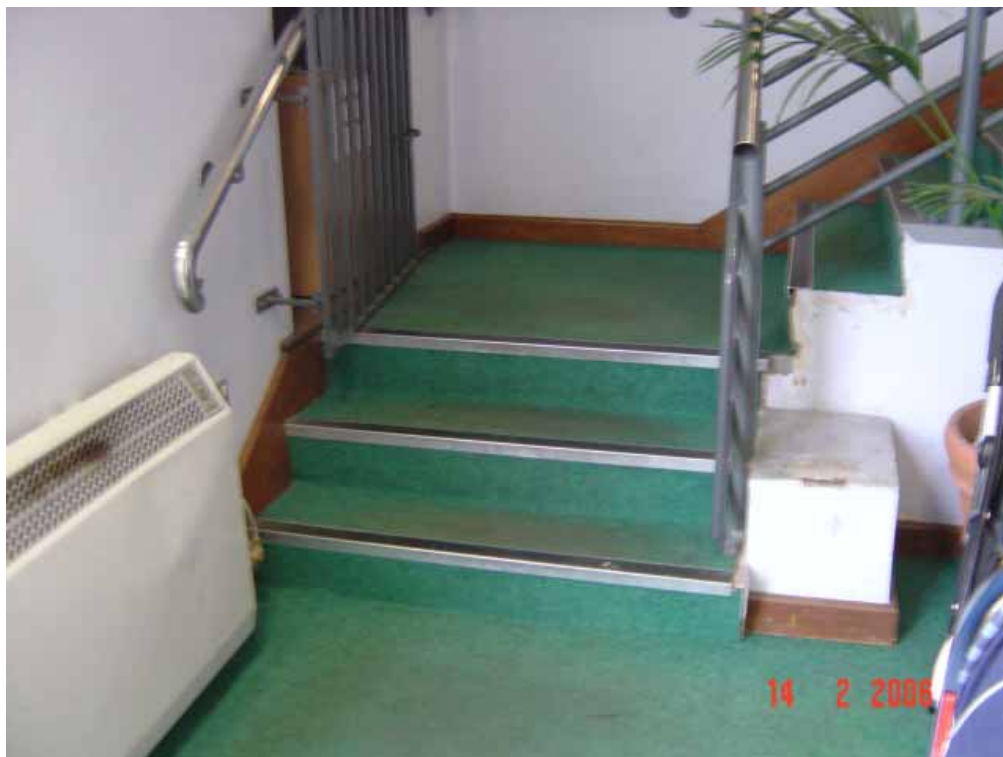
Fig 9.2 These steps make access to this office impossible for a person in a wheelchair.

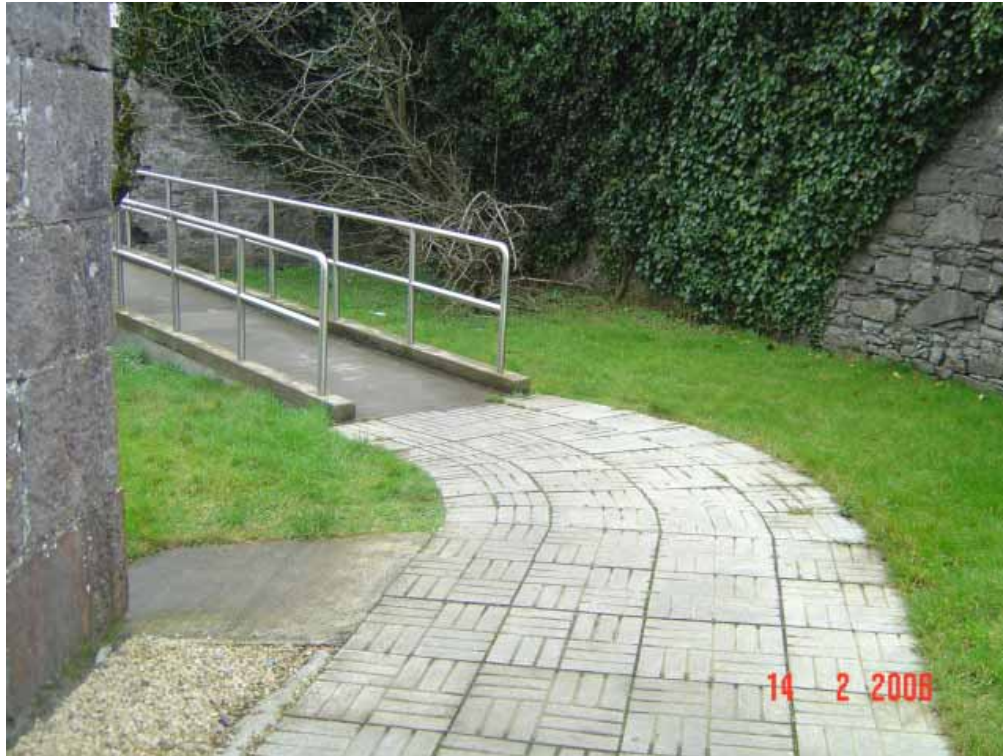
Fig 11.1 Good path leading to ramp but no tactile hazard warning strips in place.

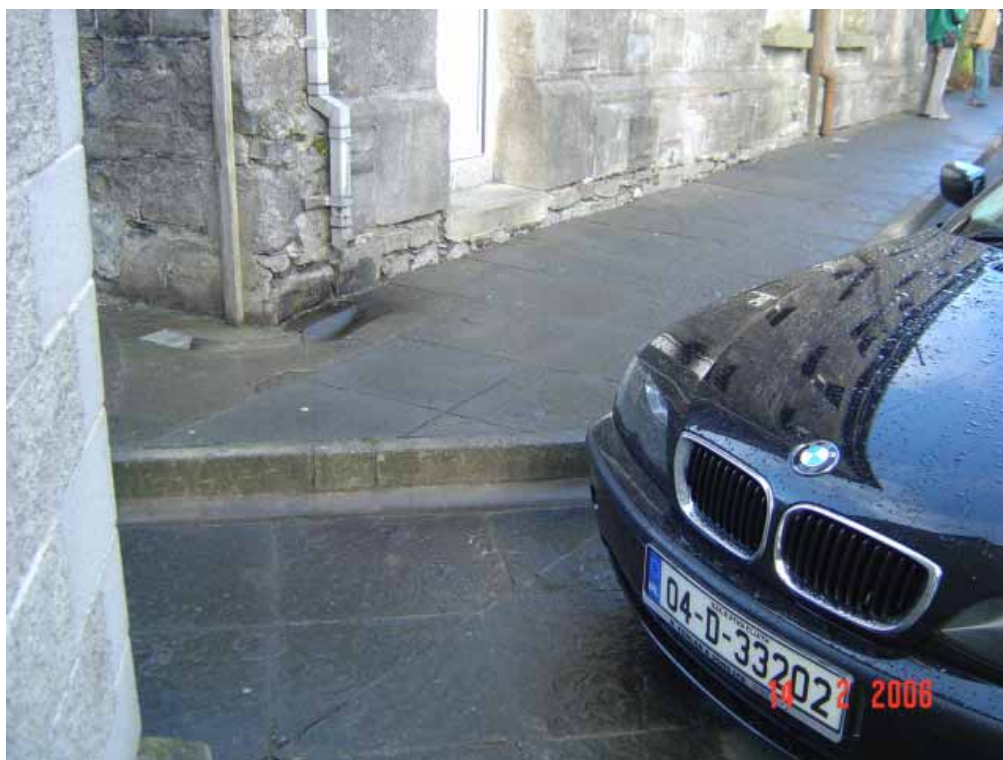
Fig 13.1 Parked cars and a step in the path make this section impossible to pass in a wheelchair.

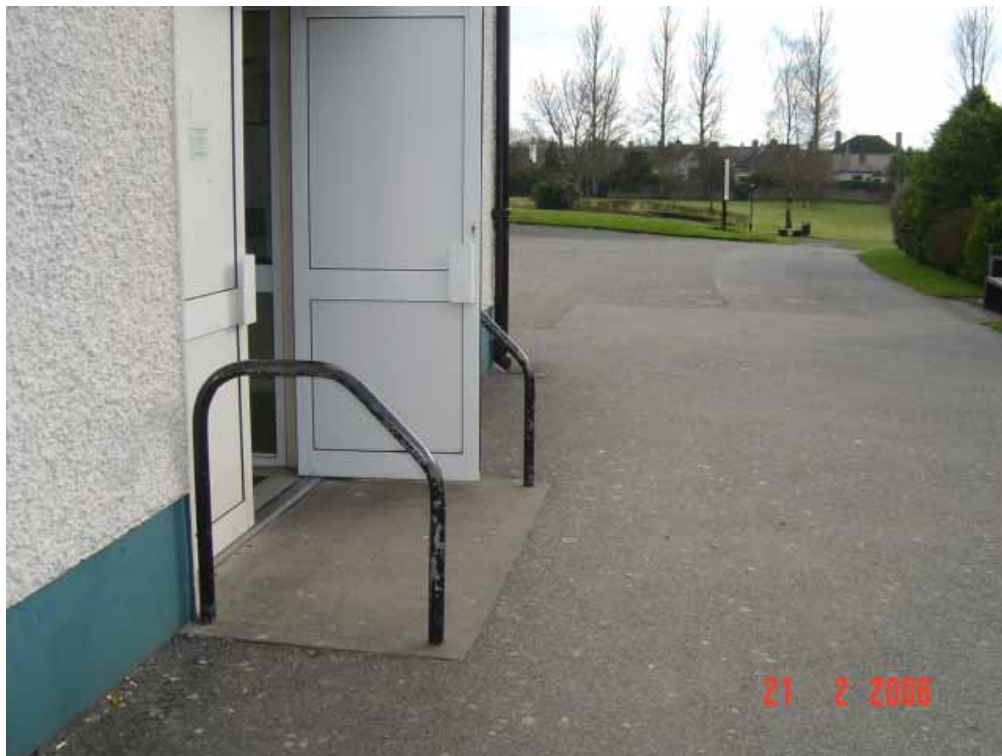
Fig 14.1 Identifiable level entrance.
